FELLOWS LAKE DAM

GREENE COUNTY, MISSOURI

MO 20036

**PHASE 1 INSPECTION REPORT  
NATIONAL DAM SAFETY PROGRAM**

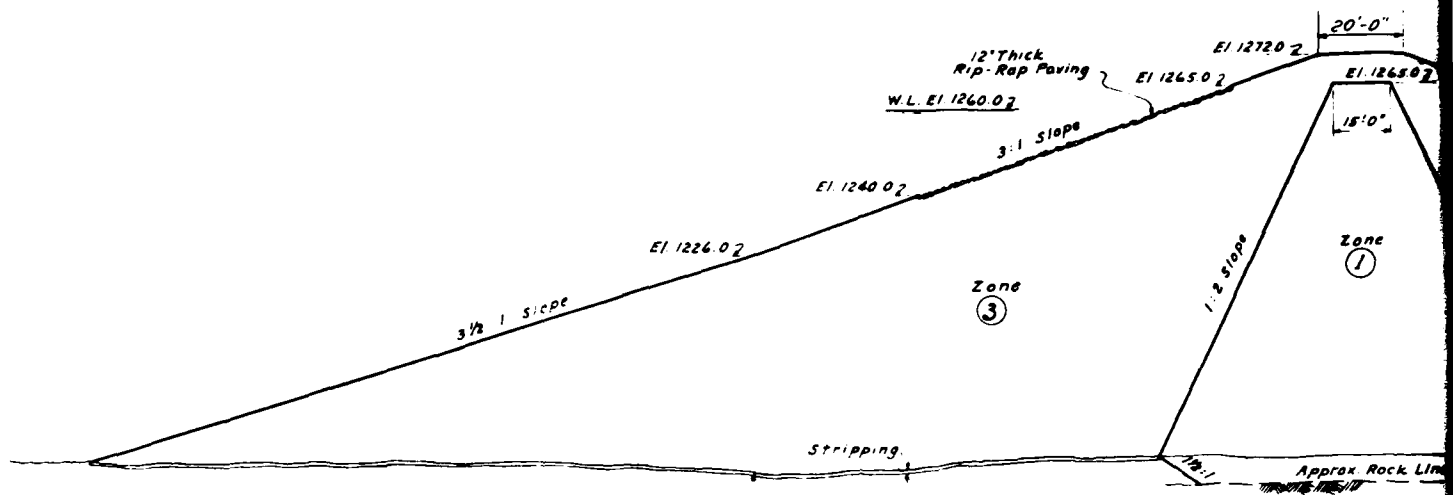
PLATE 5

The history of high phreatic surface occurrences near the berm at elevation 1210 but relatively lower concurrent observations downslope suggest the "Rip Rap Toe Drain" shown on Plate 5 to be functioning as intended. The description of this toe drain in the contract specifications is incomplete to be considered a "graded filter" by current understanding. More should be known about the material gradations and if there is zoning of different size materials. This lack of information is considered a deficiency related to the seepage analysis.

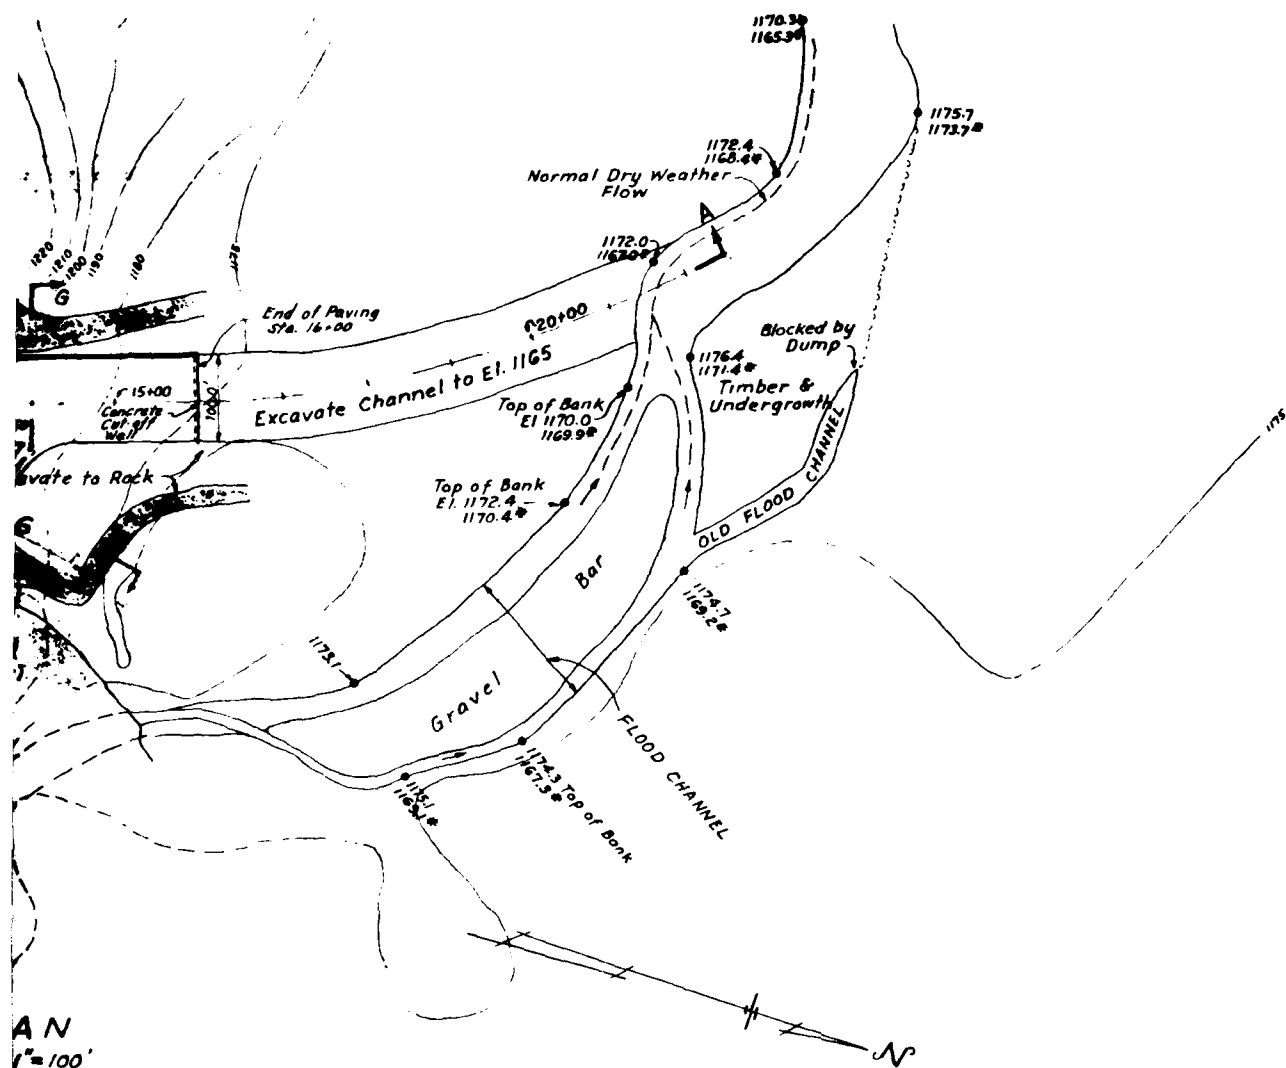
PLATE 6

THE LOWERED FLOWLINE AROUND STATION 13 TO INDUCE A HYDRAULIC JUMP WITHIN THE CONCRETE LINED SECTION OF THE CHUTE IS NOT INDICATED.
